**SPECIAL ENGINEERING SERVICES TO
ESTABLISH INSPECTION CRITERIA FOR
BEARINGS TO IMPROVE LIFE PREDICTION**

FINAL ENGINEERING REPORT

SwRI Project 15-4012

Warner Robins Air Logistics Command
Directorate of Materiel Management
Robins Air Force Base, Georgia 31093

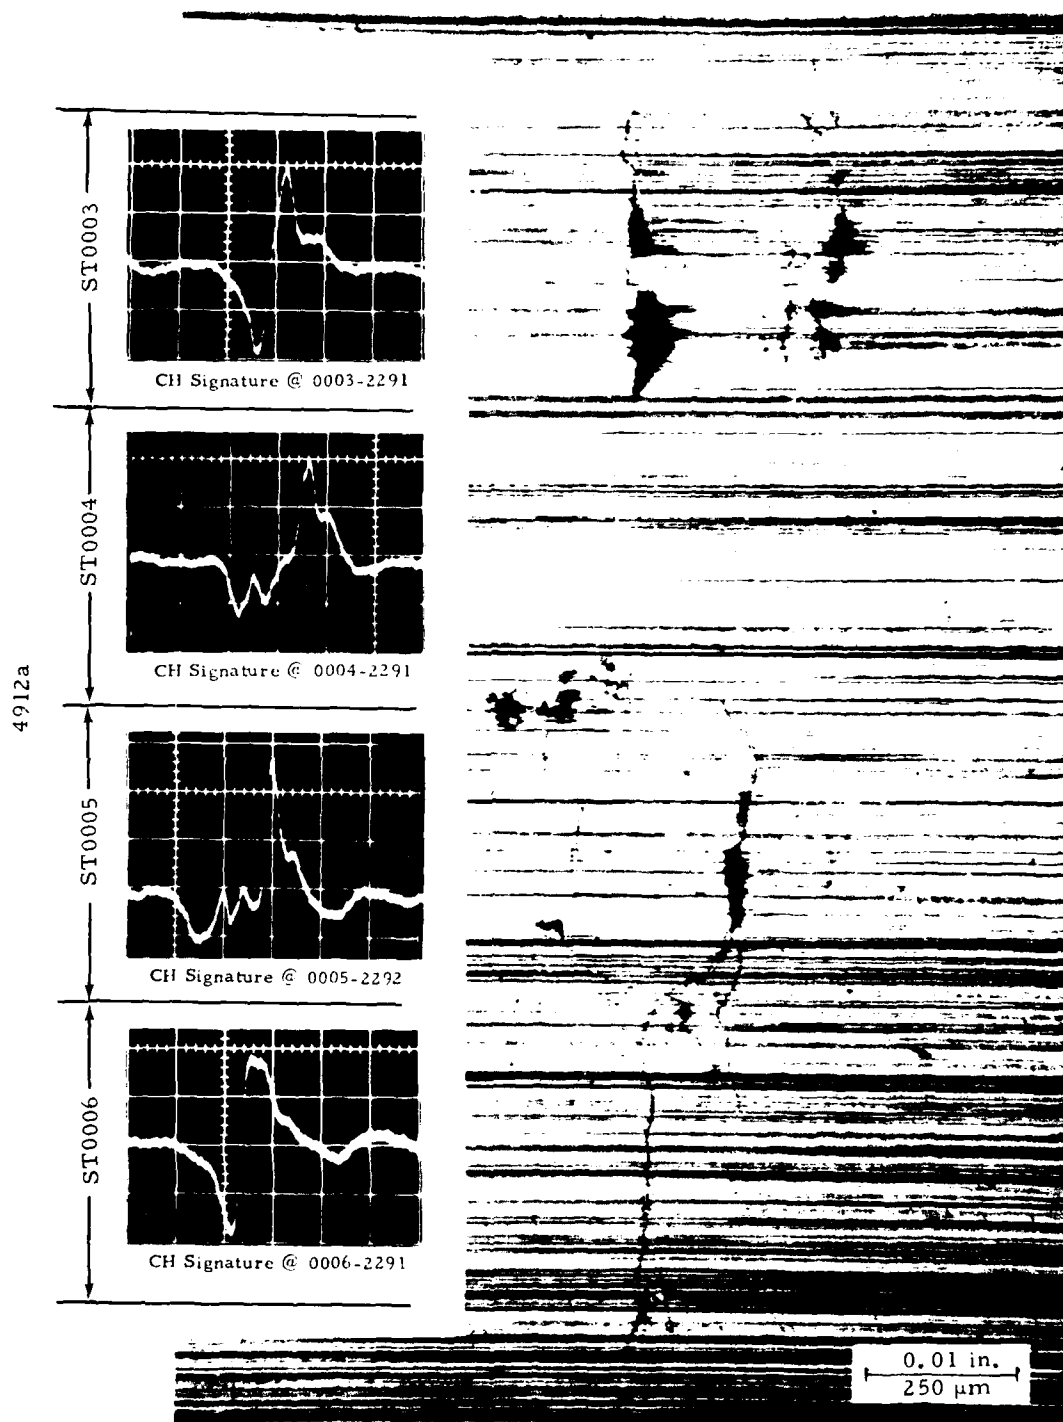
Figure 8 dramatically illustrates the capability of CIBLE to detect the presence of critical fatigue damage in bearing race components. The large crack network (~ 0.1 in. or 2.5 mm, transversely across the race) detected in the loaded half of an inner race of a J57-#2, vendor reworked bearing (S/N 144D-2). Typical CH signatures included in Figure 8 correspond with the programmed scan tracks from which the signatures were obtained. The bearing race was subsequently endurance tested for a total of 3 hours at a maximum Hertz stress of 204 ksi*. These test conditions were selected to minimize the probability of a failure. Fortunately, spall-type failure did not result from the 3 hour endurance test; however, significant, visually evident crack propagation did occur and it is estimated that the remaining life of this component in an engine would be only a few hours. Subsequent to the endurance test, metallurgical investigation of the cracked region illustrated in Figure 8 was completed and confirmed that inclusions were the nucleating source for the cracks; detailed results are presented later in this report.

FIGURE 8. CIBLE RESULTS SHOWING SURFACE PHOTOMICROGRAPH ($\times 100X$) OF CRACK NETWORK AND ASSOCIATED CIRCUMFERENTIAL FLUX SIGNATURES

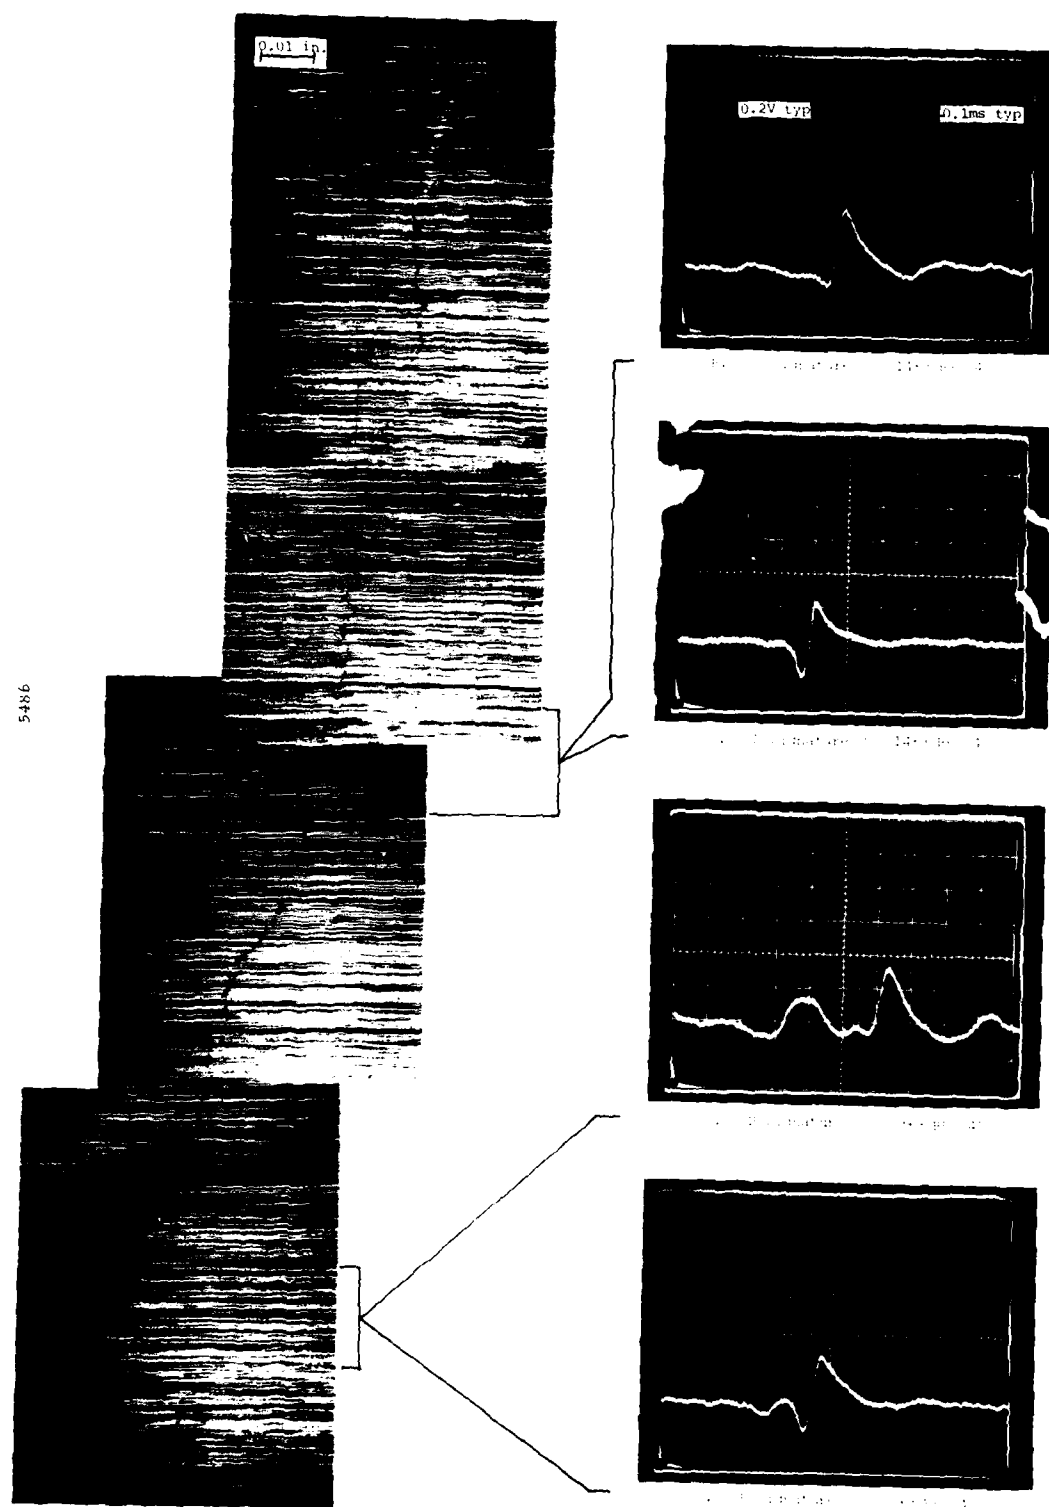
The results in Figure 9 illustrate, equally dramatically, that significant inclusions are present, occasionally, in new bearings fabricated from premium quality steel which can lead to the initiation and propagation of cracks such as previously shown in Figure 8. Again in Figure 9, significant CH signatures are presented which correspond to apparently innocuous surface indications. The surface indications illustrated in the photomicrograph A of Figure 9 suggest a long ($\sim .025$ in. or 0.64 mm in length) stringer type inclusion. If the inclusion were superficial only radial flux signatures would be generated; however, the significant CH signatures in Figure 9 confirm that a large inclusion extends beneath the surface. These CIBLE results were obtained from the inner race half which would be loaded in engine service of a J57-#4 bearing (S/N 534A-1). It is anticipated that the life of this component in engine service would be severely limited by the presence of the flaw indicated in Figure 9.

FIGURE 9. CIBL RESULTS ON NEW J57-#4 BEARING (S/N 534A-1)
 INNER RACE, LOADED HALF (S12671-2)

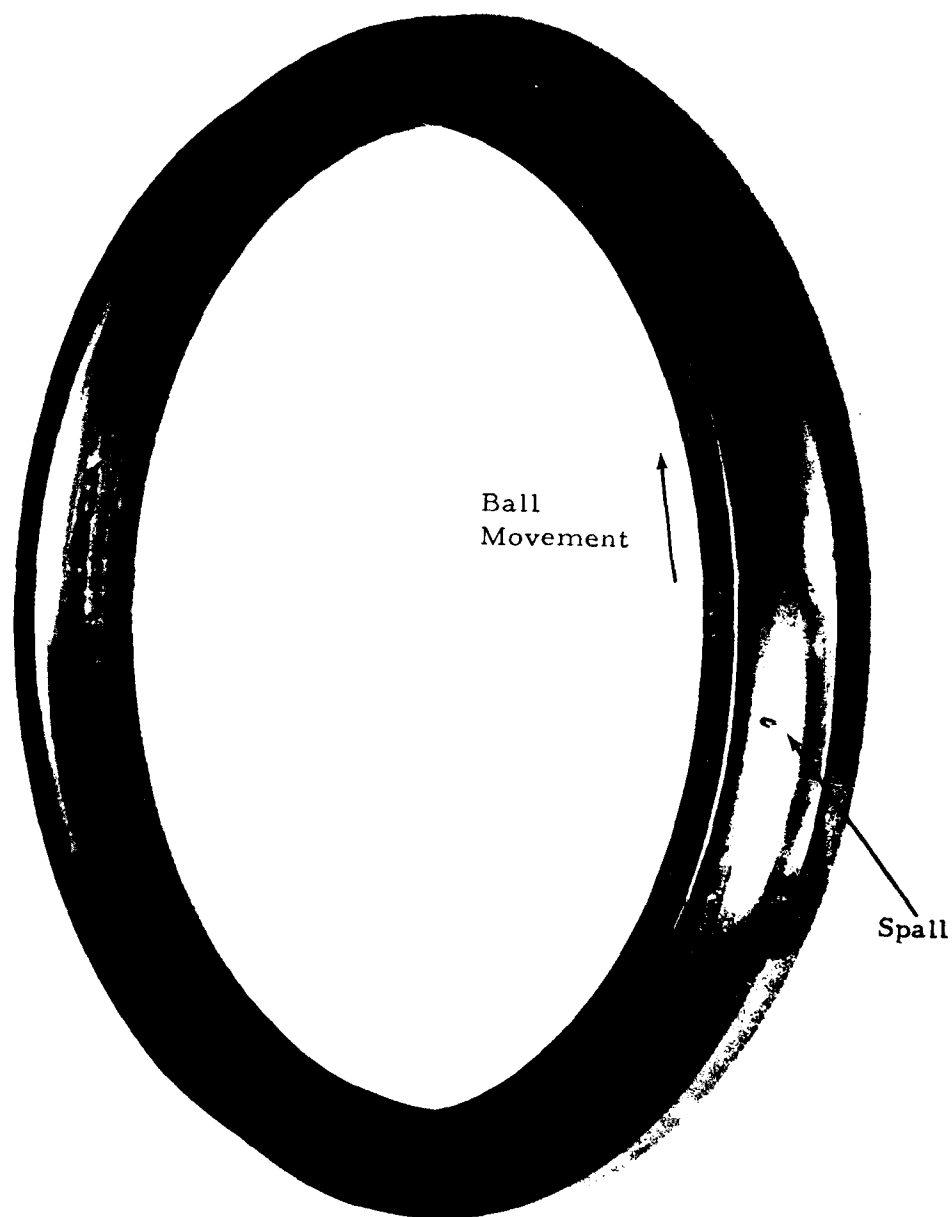
FIGURE 20. VERY SMALL SPALL WHICH DEVELOPED AFTER 30 HOURS TOTAL
ENDURANCE TEST TIME, J57-#4, S/N 219A-2 (S12052-1)

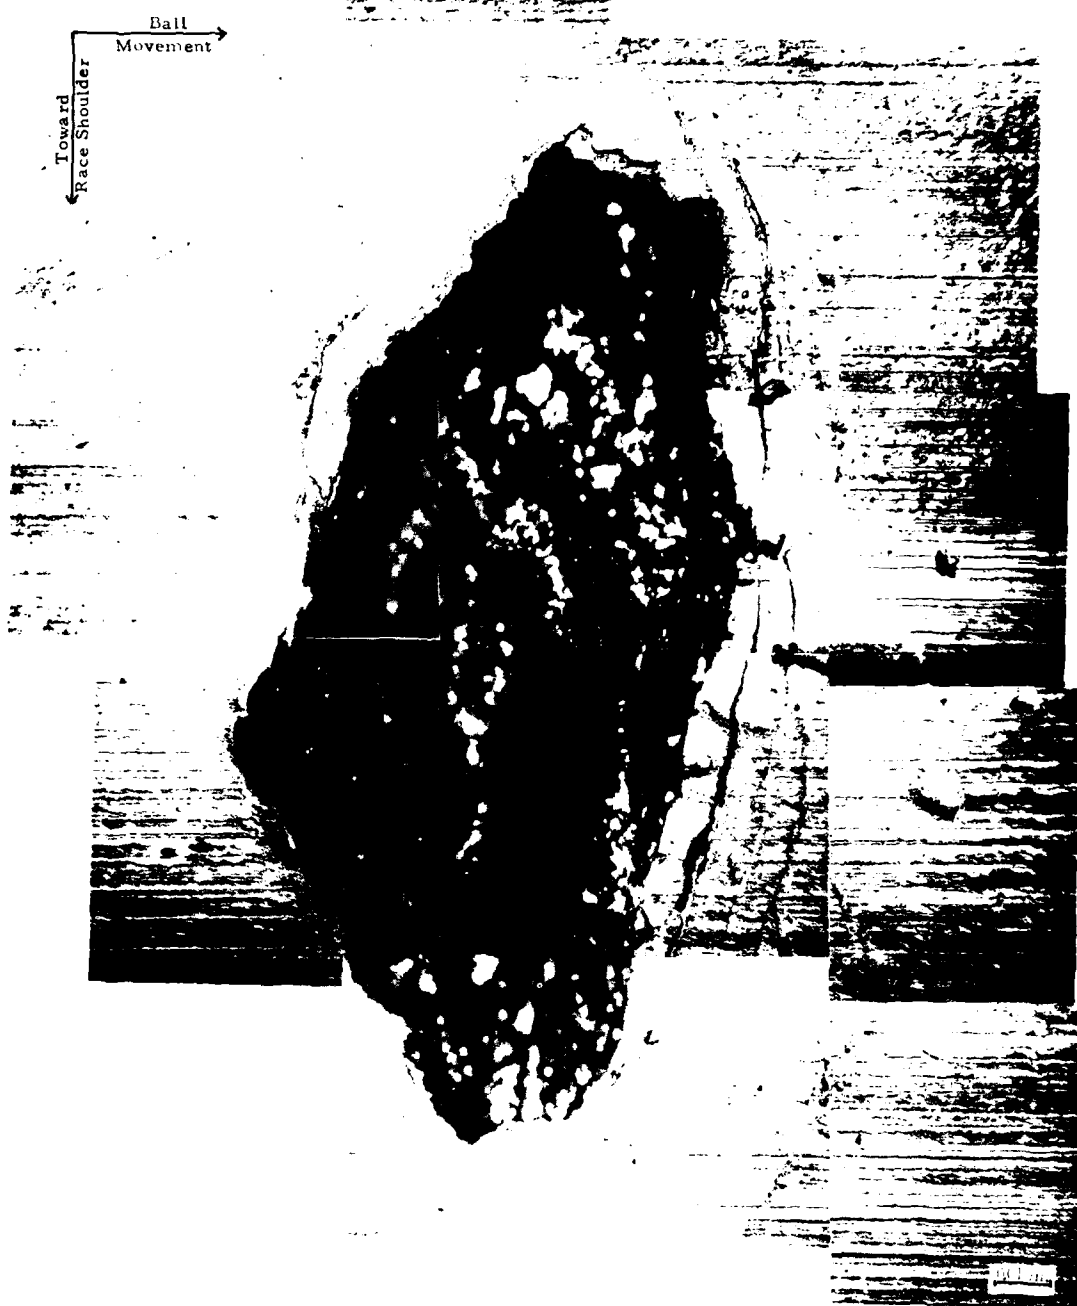
FIGURE 21. SURFACE PHOTOMICROGRAPH OF SPALL REGION ON
J57-#4 INNER BEARING RACE, S/N 219A-2 (S12052-1).

If the failure was a truly randomly originated event, there would be approximately 400,000 unit cells (0.003 in. by 0.003 in.) at the surface within which the failure could have initiated. The fact that it was possible to forecast the precise initiation location even though no prominent anomaly was observed on the surface demonstrates the effectiveness of the CIBLE inspection methodology.

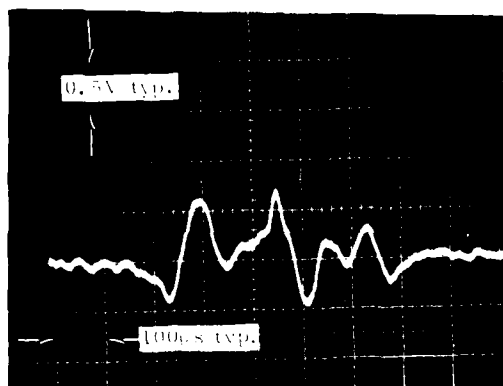
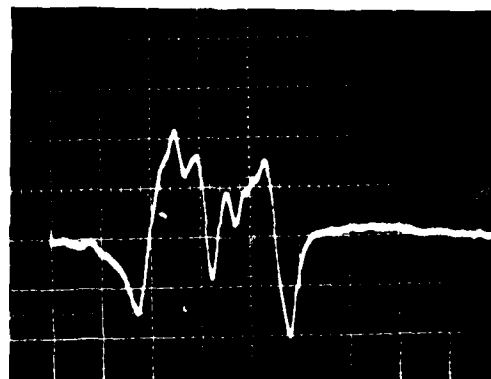
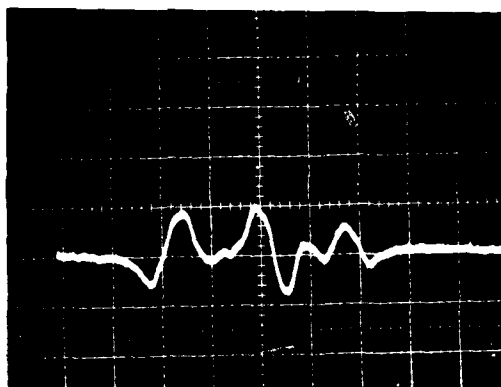
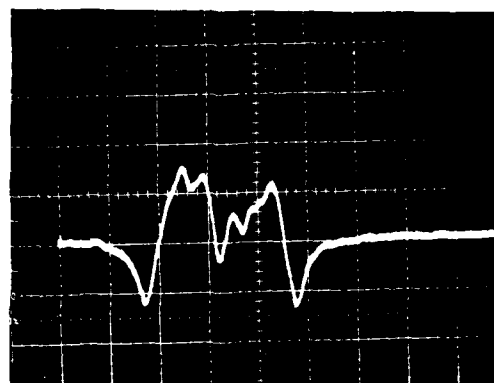
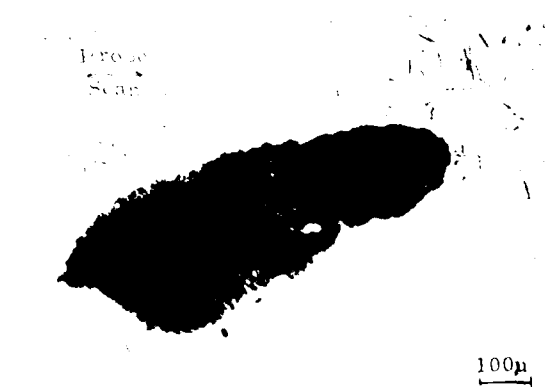
FIGURE 24. CIBLE INSPECTION SIGNATURES AND SURFACE PHOTOMICROGRAPHS
SHOWING CORRESPONDING SURFACE FLAWS ON BALL WITH 3230 HRS.
SERVICE, J57-#4 BEARING S/N 9117-2 (Ball #20, Defects 1 and 2).

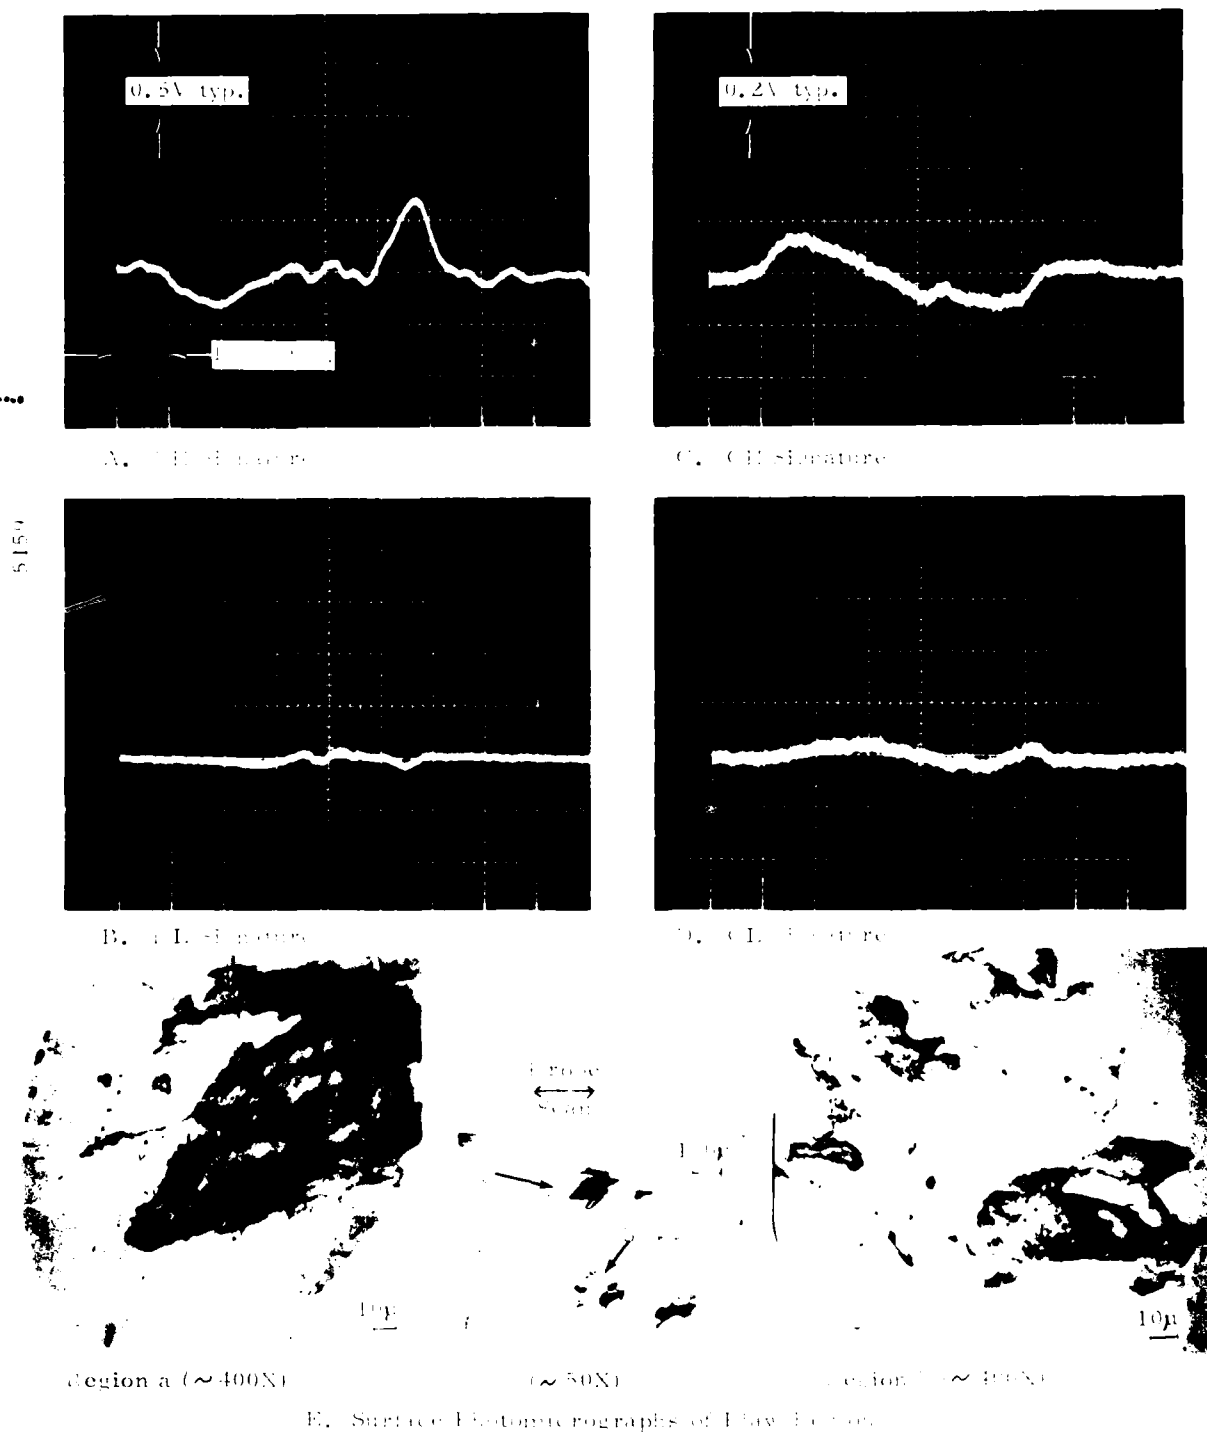
FIGURE 27. CIBL INSPECTION SIGNATURES AND CORRESPONDING SURFACE PHOTOMICROGRAPHS SHOWING PITS AND CRACKS ON NEW BALL FROM VENDOR REWORKED J57-#4 BEARING S/N 395-2, 4362 HRS (Ball #11, S11672).

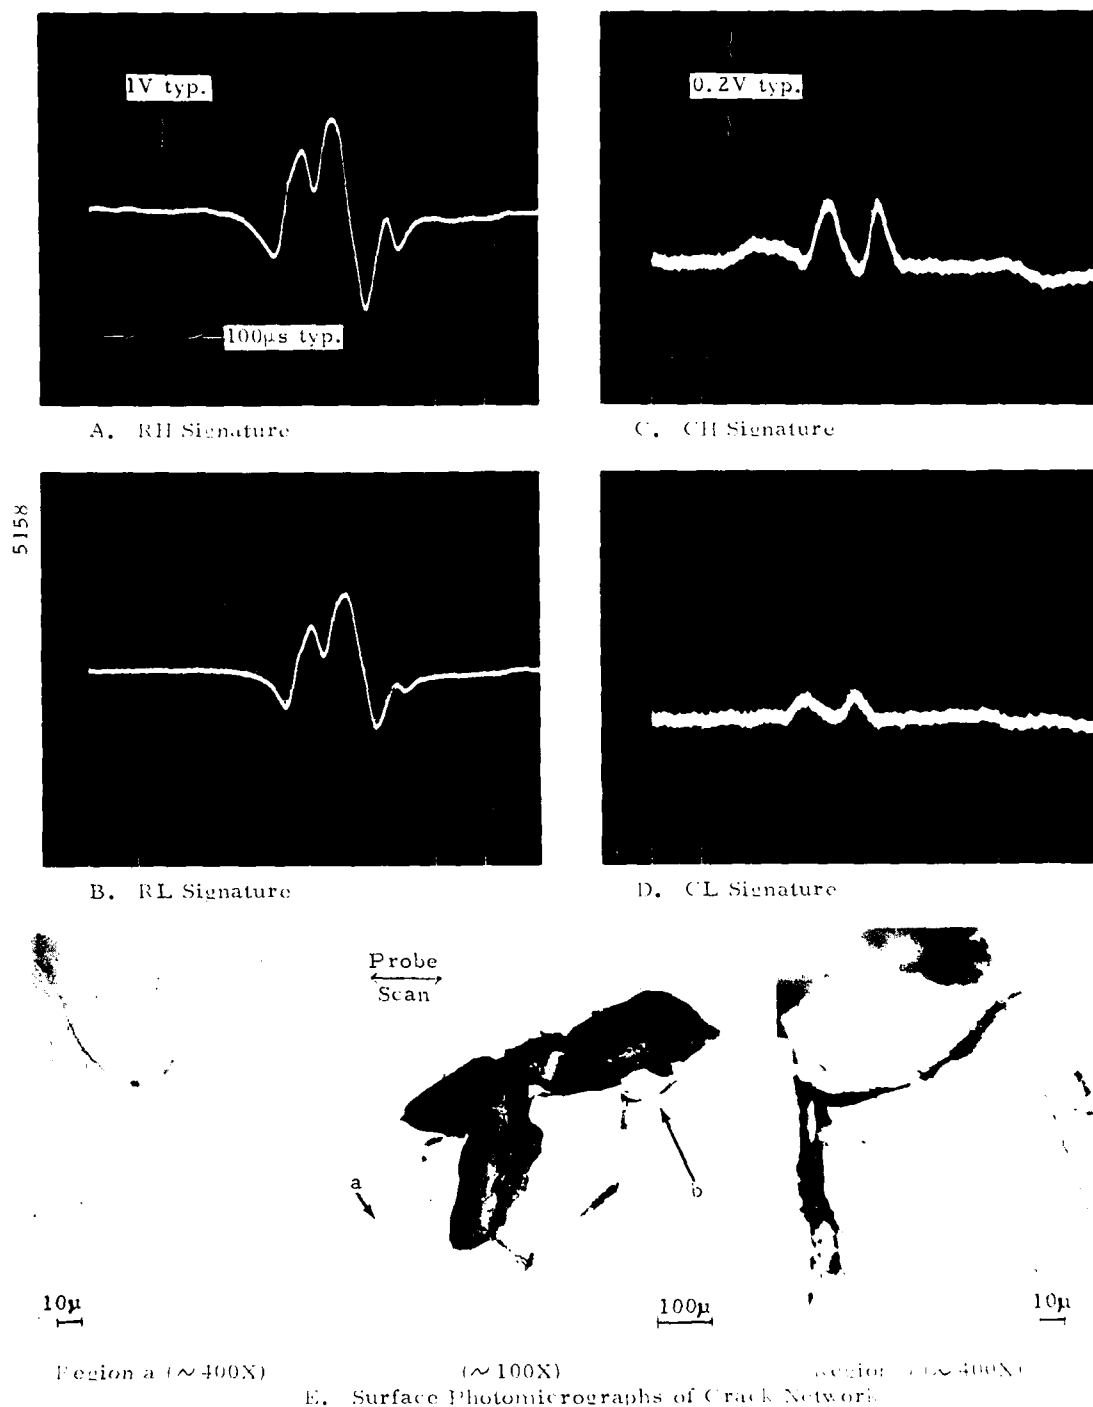
FIGURE 28. CIBL INSPECTION SIGNATURES AND CORRESPONDING SURFACE PHOTOMICROGRAPHS SHOWING CRACK NETWORK ON NEW BALL FROM VENDOR REWORKED J57-#4 BEARING S/N 395-2, 4362 HRS (Ball #3, S11672).

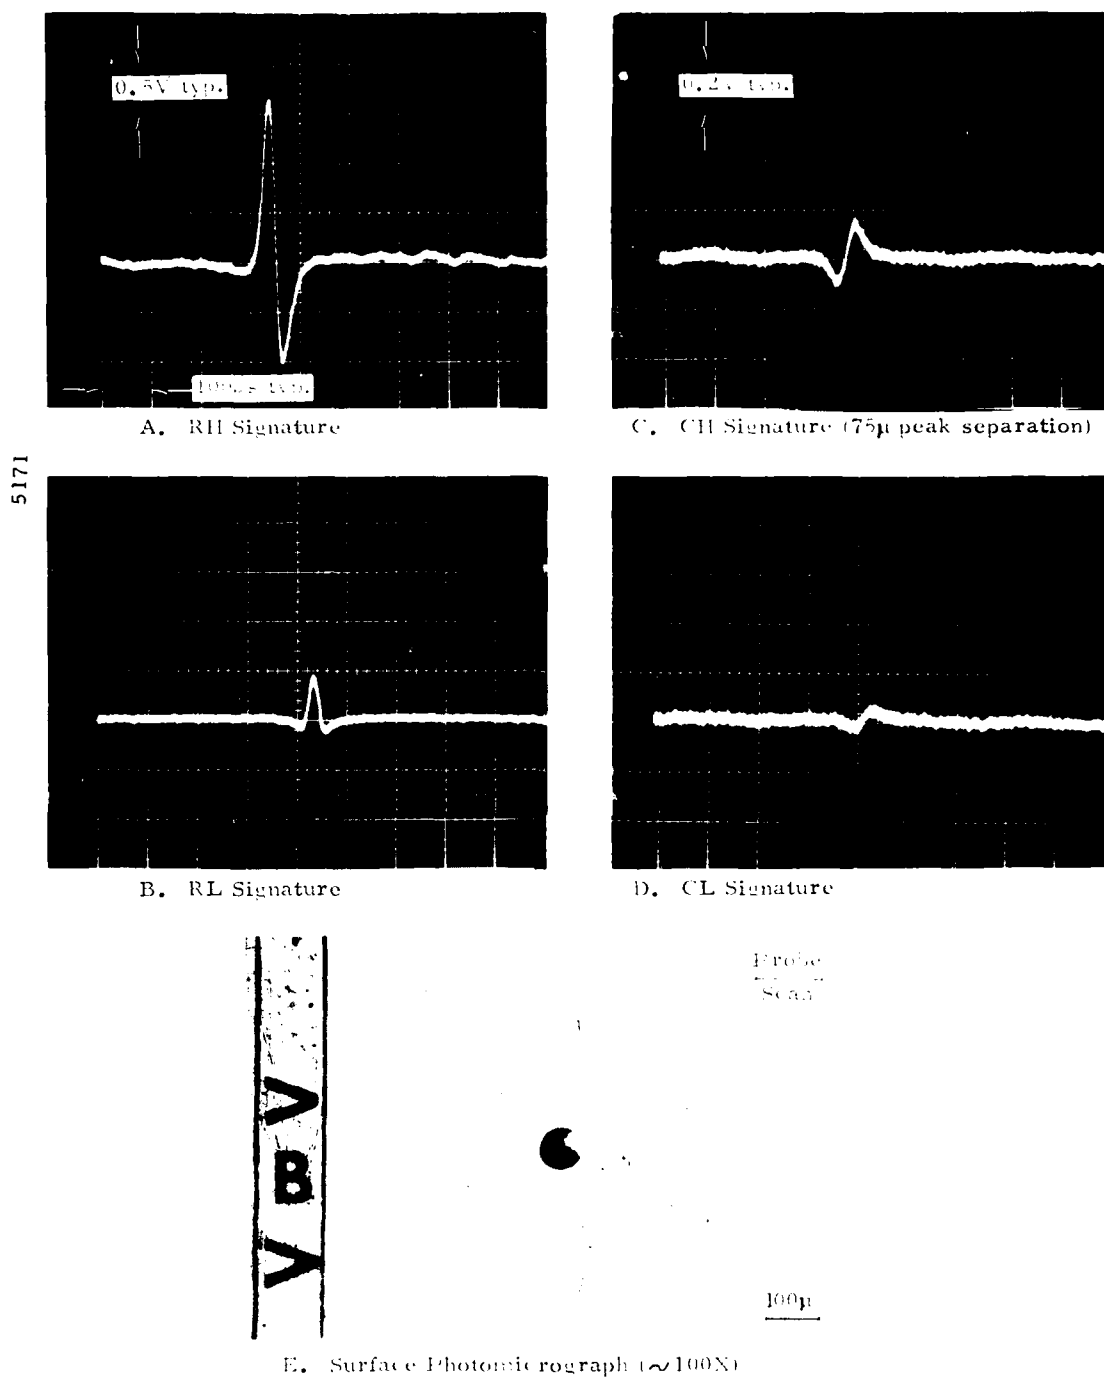
FIGURE 6. CIBLE INSPECTION SIGNATURES AND CORRESPONDING SURFACE PHOTOMICROGRAPH SHOWING INCLUSION ON SURFACE OF NEW BALL FROM VENDOR REWORKED J57-#4 BEARING S/N 3453-2, 5940 HRS (Ball #12, S11092).

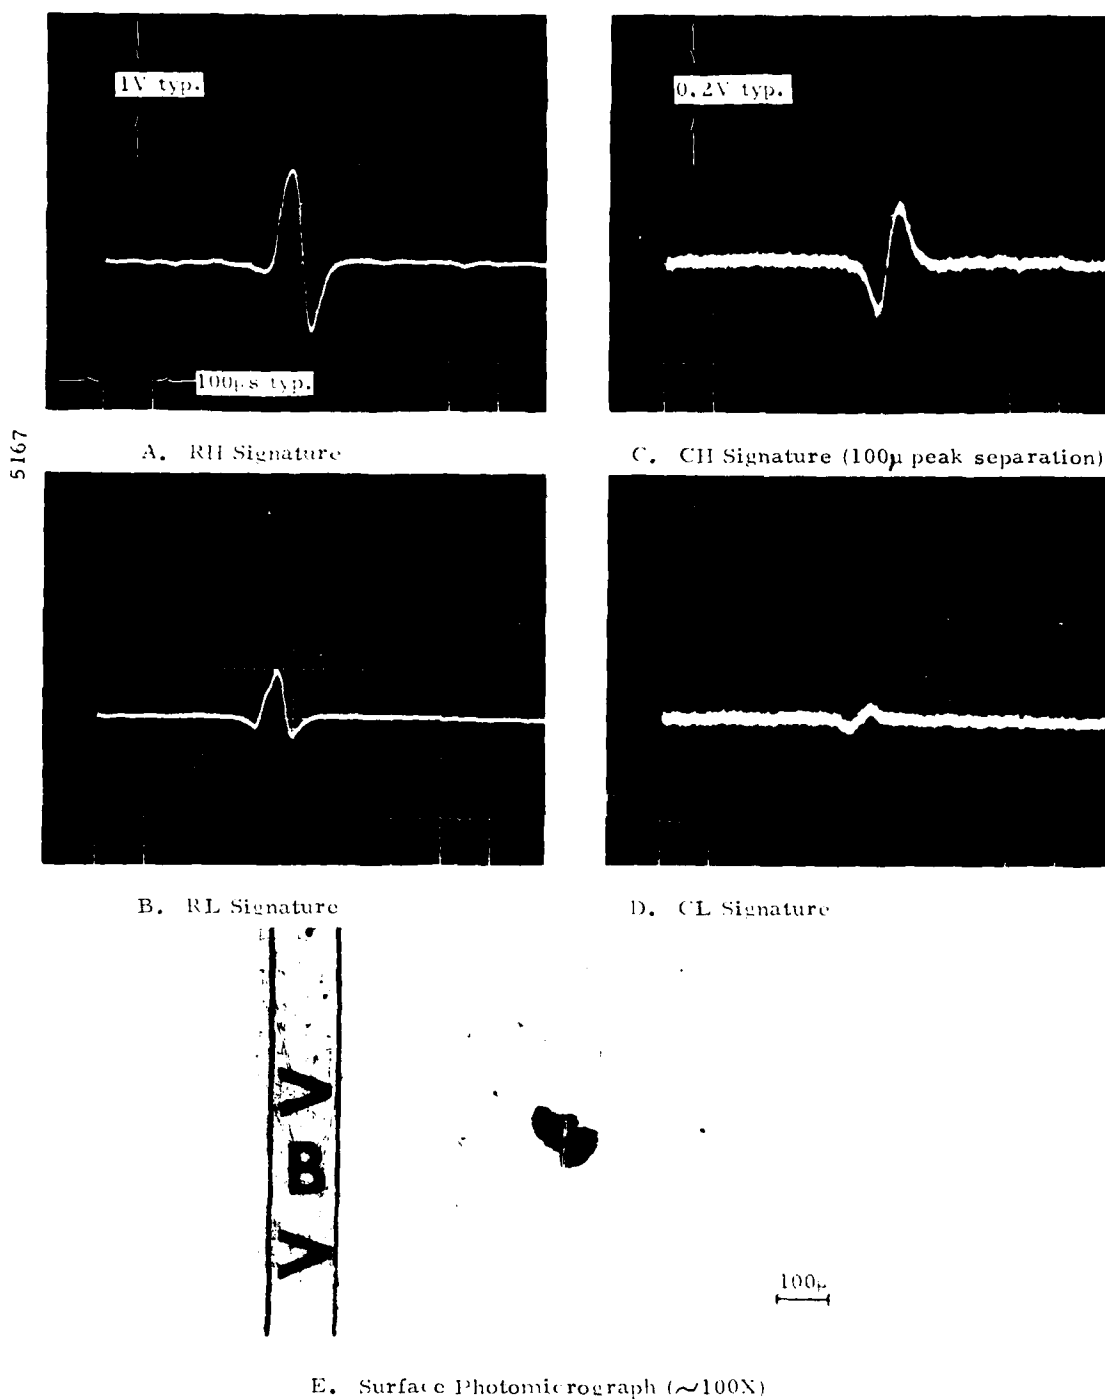
FIGURE 7. CIBLE INSPECTION SIGNATURES AND CORRESPONDING SURFACE PHOTOMICROGRAPH SHOWING INCLUSION ON SURFACE OF NEW BALL FROM VENDOR REWORKED J57-#4 BEARING S/N 3453-2, 5940 HRS (BALL #13, S11092).

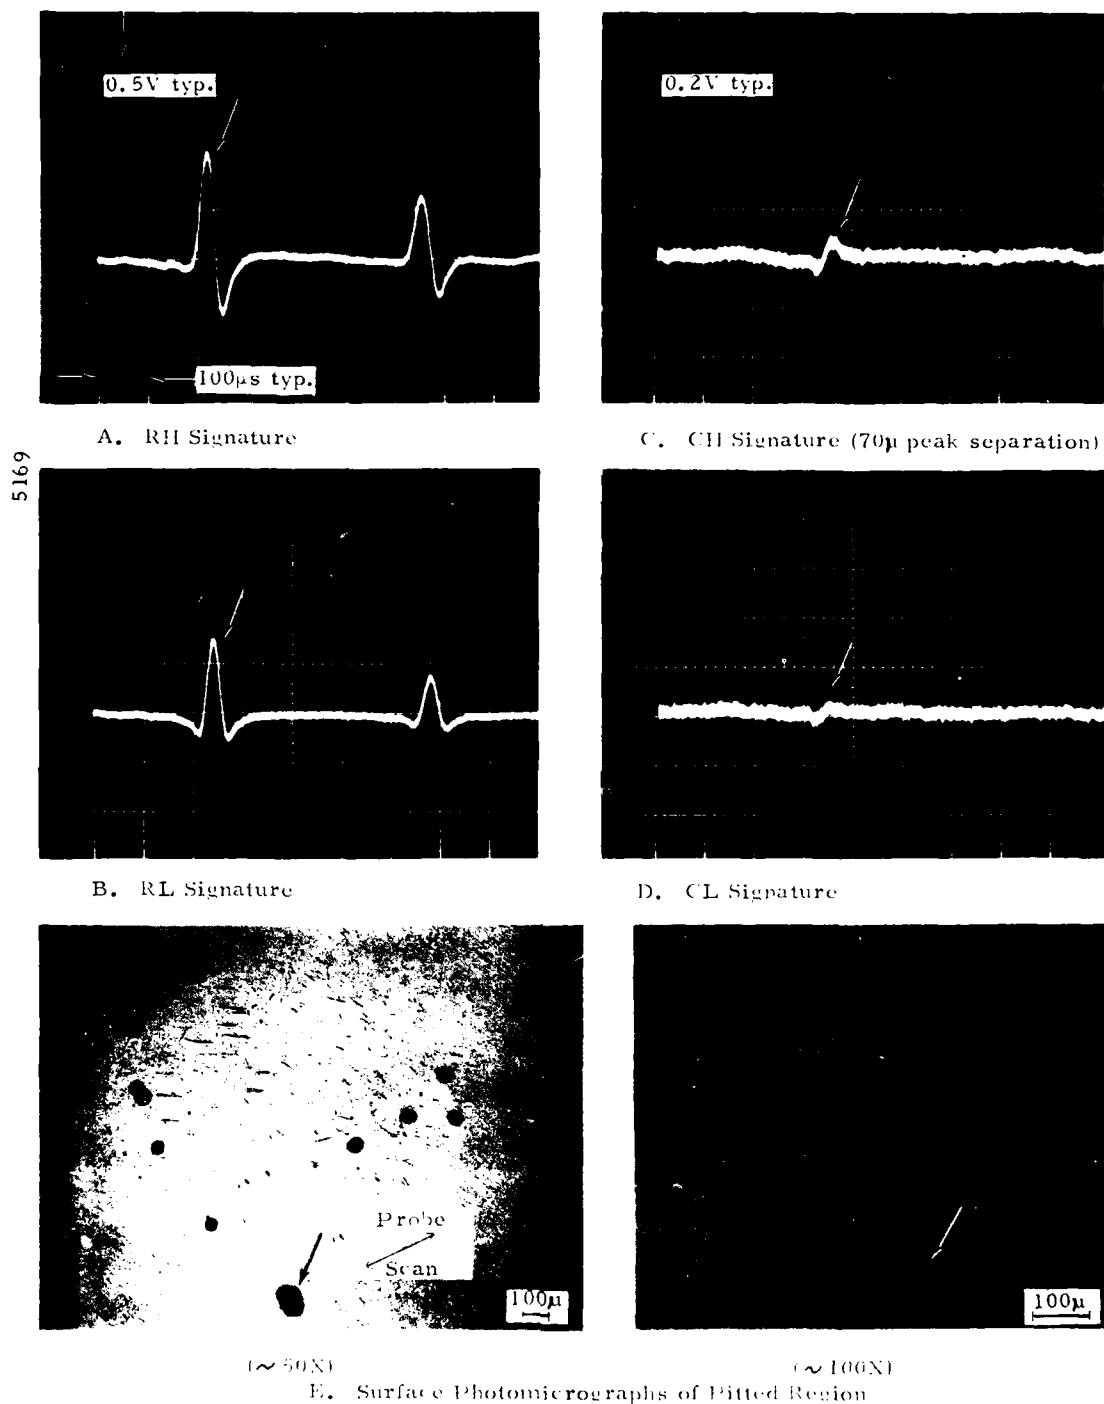
FIGURE 8. CIBLE INSPECTION SIGNATURES AND CORRESPONDING SURFACE PHOTOMICROGRAPHS SHOWING PITTED REGION ON NEW BALL FROM VENDOR REWORKED J57-#4 BEARING S/N 3083-2, 4769 HRS (Ball #7).

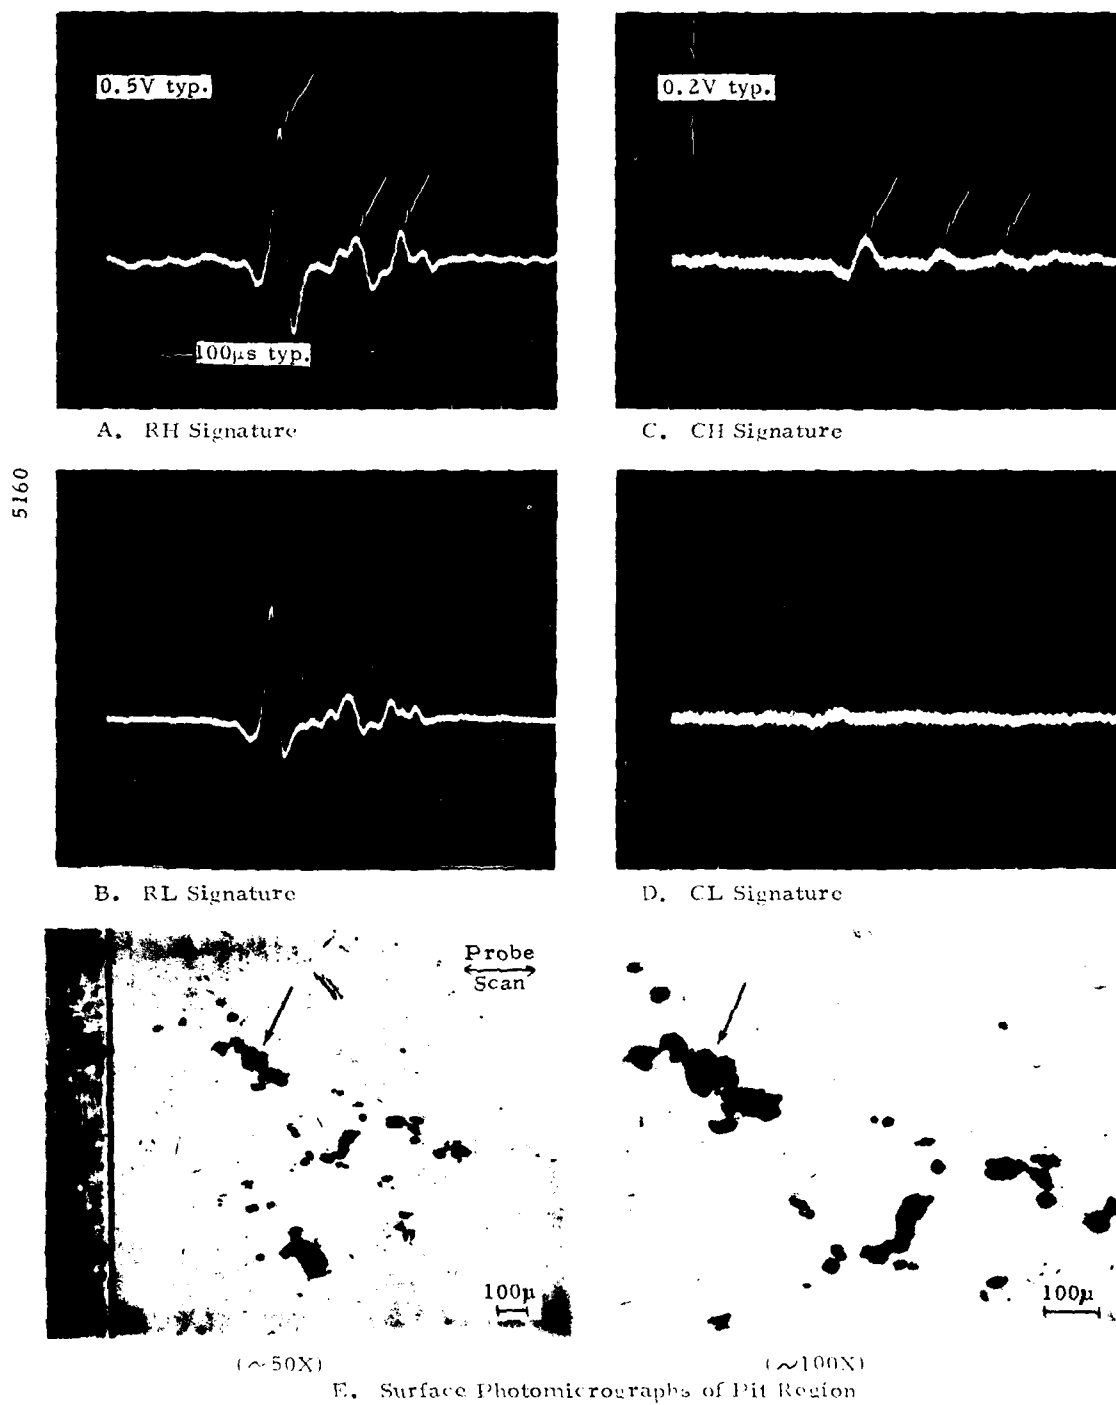
FIGURE 9. CIBLE INSPECTION SIGNATURES AND CORRESPONDING SURFACE PHOTOMICROGRAPHS SHOWING PITTED REGION ON NEW BALL FROM VENDOR REWORKED J57-#4 BEARING S/N 395-2, 4362 HRS (Ball #20, S11672).

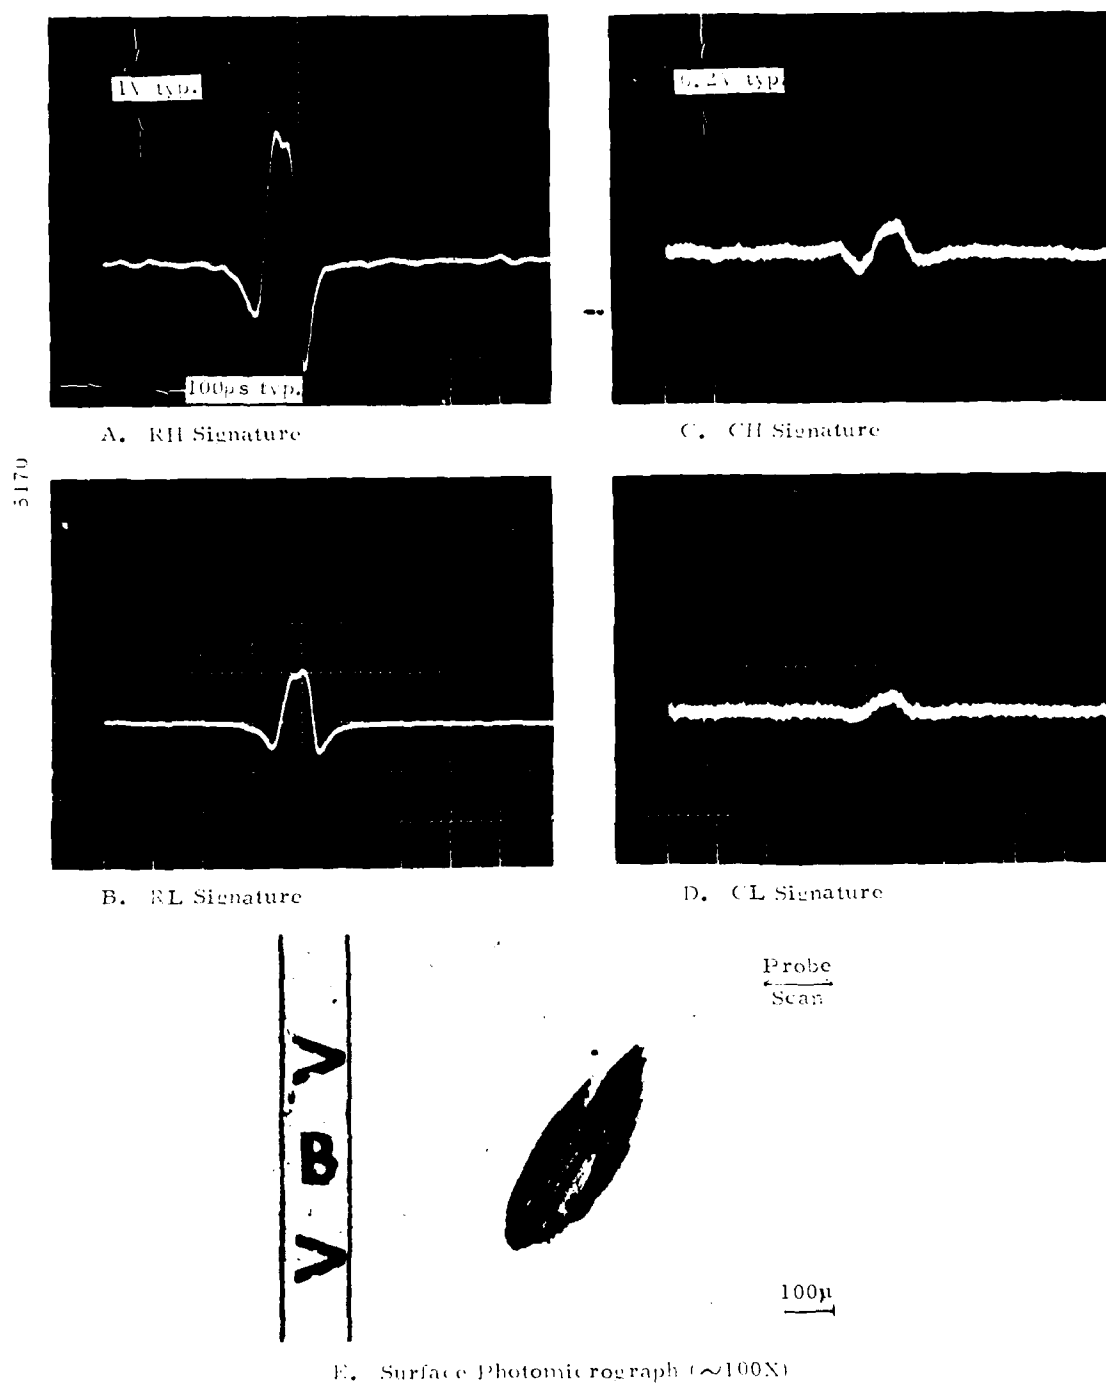
FIGURE 11. CIBLE INSPECTION SIGNATURES AND CORRESPONDING SURFACE PHOTOMICROGRAPH SHOWING GOUGE ON NEW BALL FROM VENDOR REWORKED J57-#4 BEARING S/N 9293-1, 6651 HRS (Ball #4, S11931).

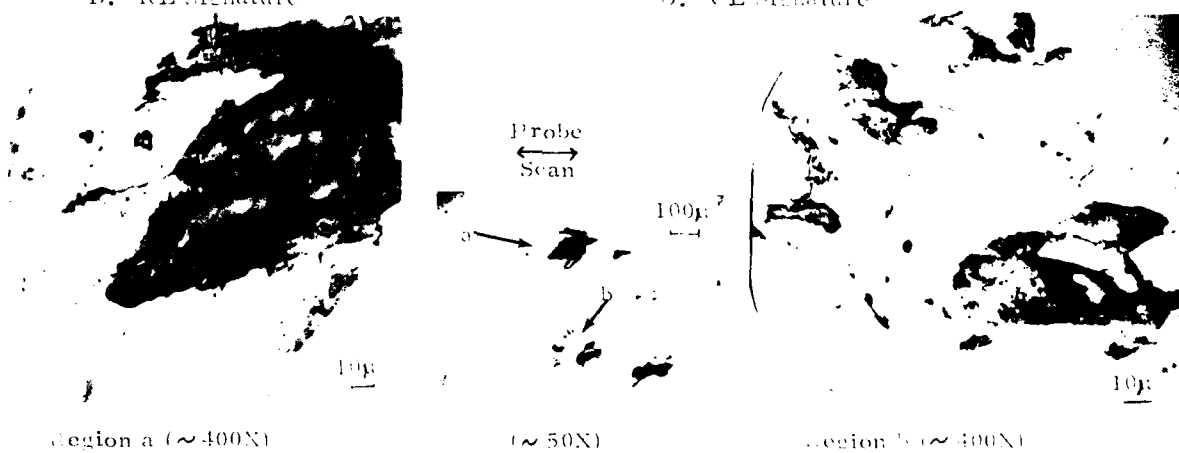
FIGURE 12. CIBLE INSPECTION SIGNATURES AND CORRESPONDING SURFACE PHOTOMICROGRAPHS SHOWING PITS AND CRACKS ON NEW BALL FROM VENDOR REWORKED J57-#4 BEARING S/N 395-2, 4362 HRS (Ball #11, S11672).

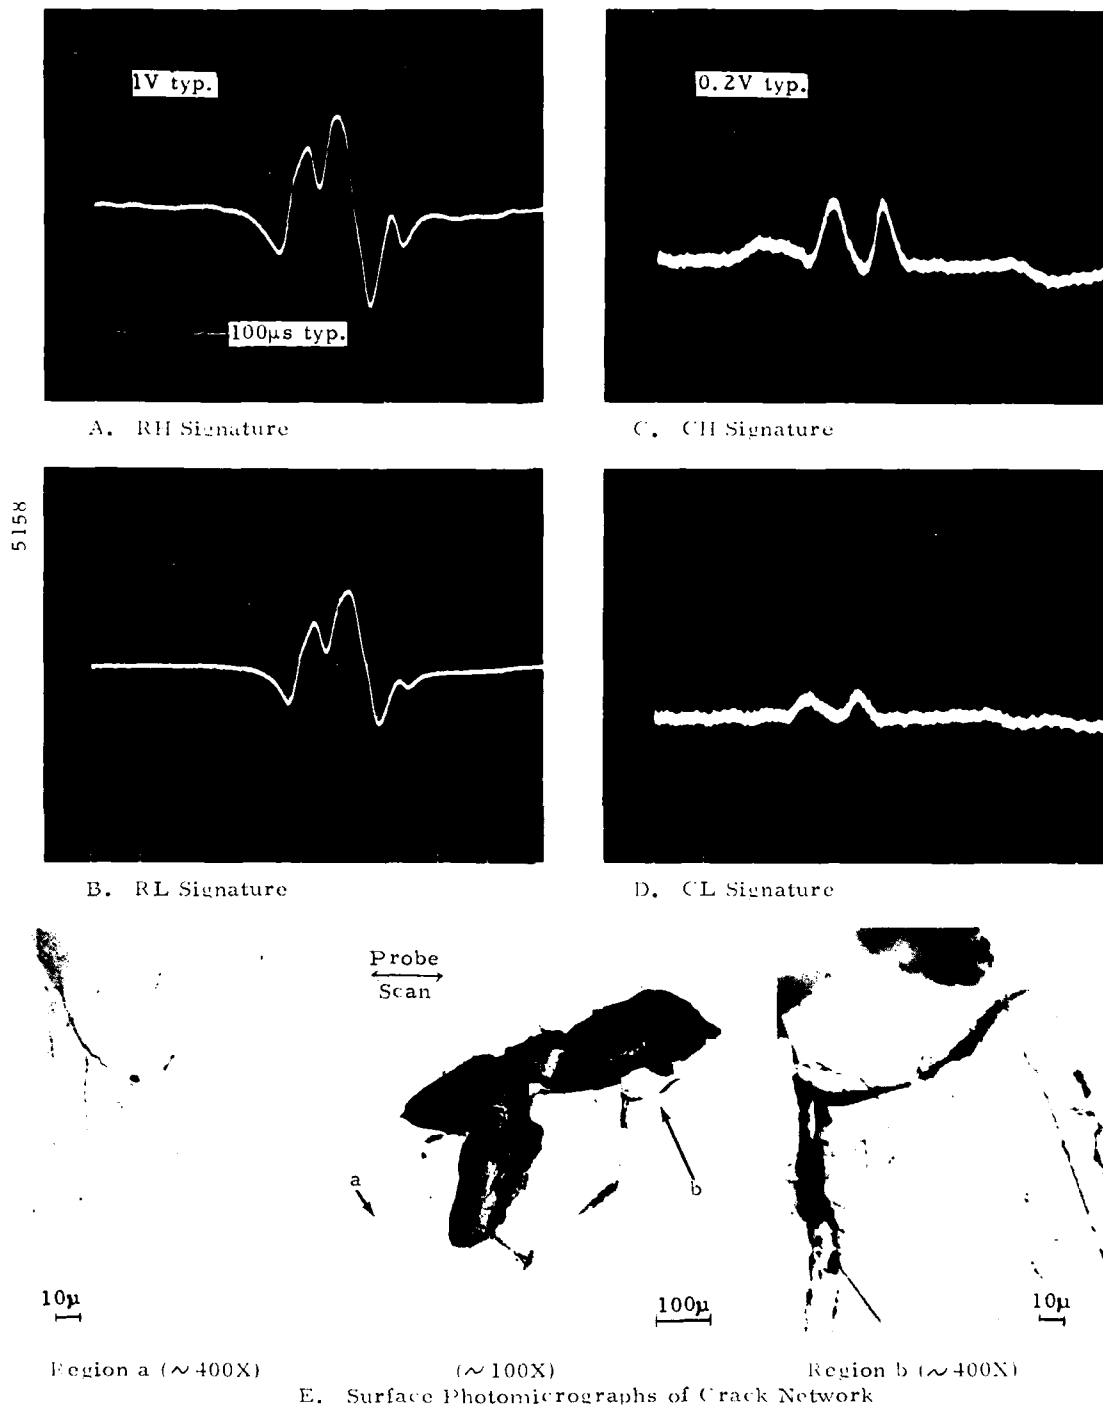
FIGURE 13. CIBLE INSPECTION SIGNATURES AND CORRESPONDING SURFACE PHOTOMICROGRAPHS SHOWING CRACK NETWORK ON NEW BALL FROM VENDOR REWORKED J57-#4 BEARING S/N 395-2, 4362 HRS (Ball #3, S11672).

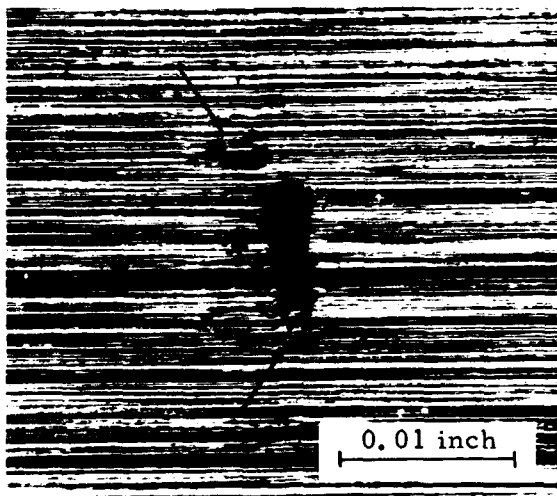
Magnified (100X) View of Surface Showing the
Flaw that Caused the CH and RH Signatures

FIGURE F2. CIBLE RESULTS ON J57-#2 BEARING (S/N B1274-2) INNER RACE
 (Reworked bearing accepted by Air Force and considered
 equivalent to new bearing.)

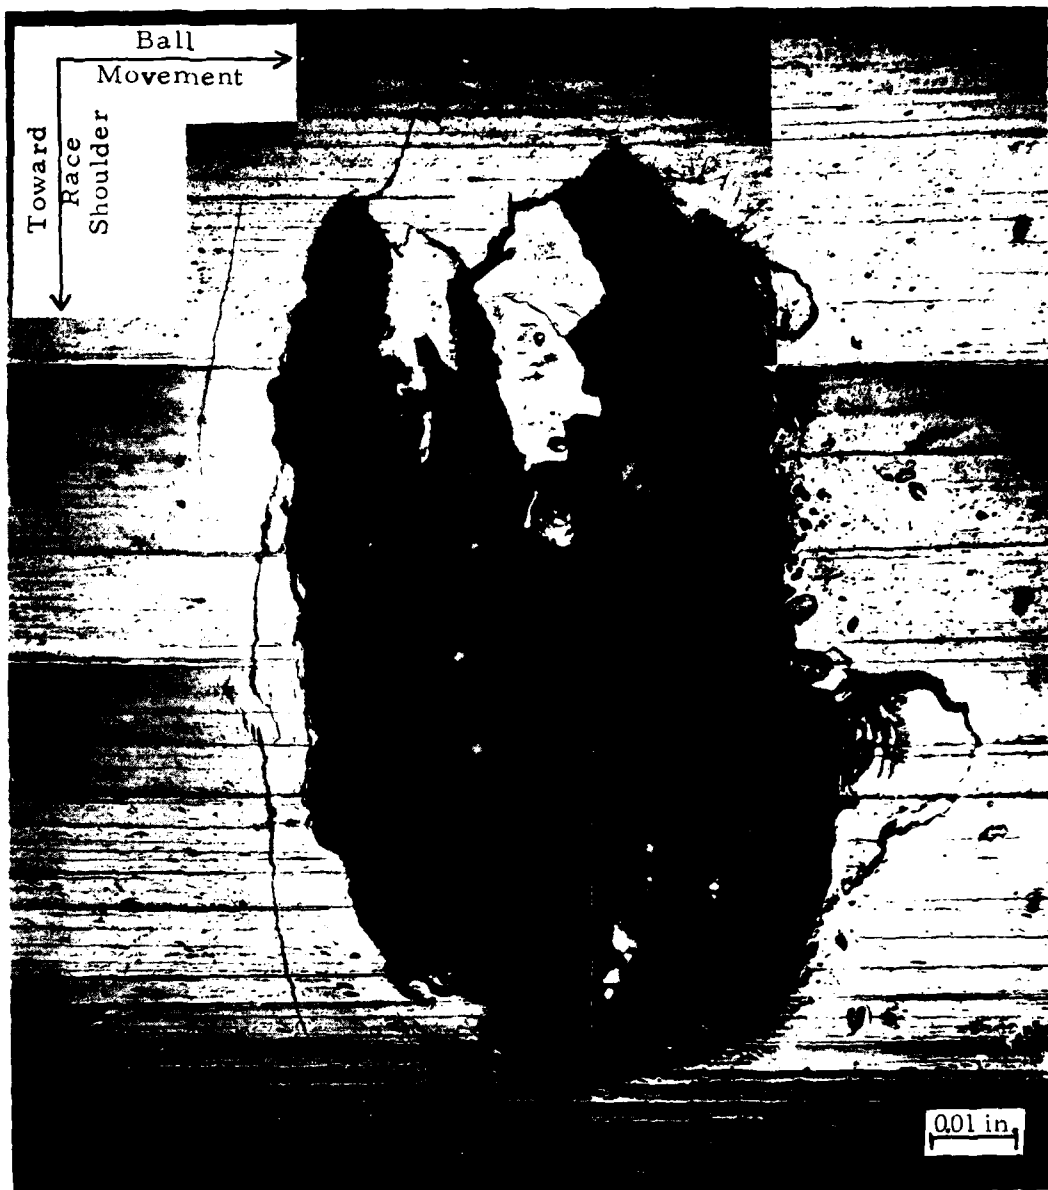
FIGURE F5. SURFACE PHOTOMICROGRAPH OF SPALL REGION ON J57-#2 INNER BEARING RACE, S/N B1274-2 (S00032-3, Service-loaded half).
